# Brocade Fabric OS v5.0.4a Release Notes v1.0

April 14, 2006

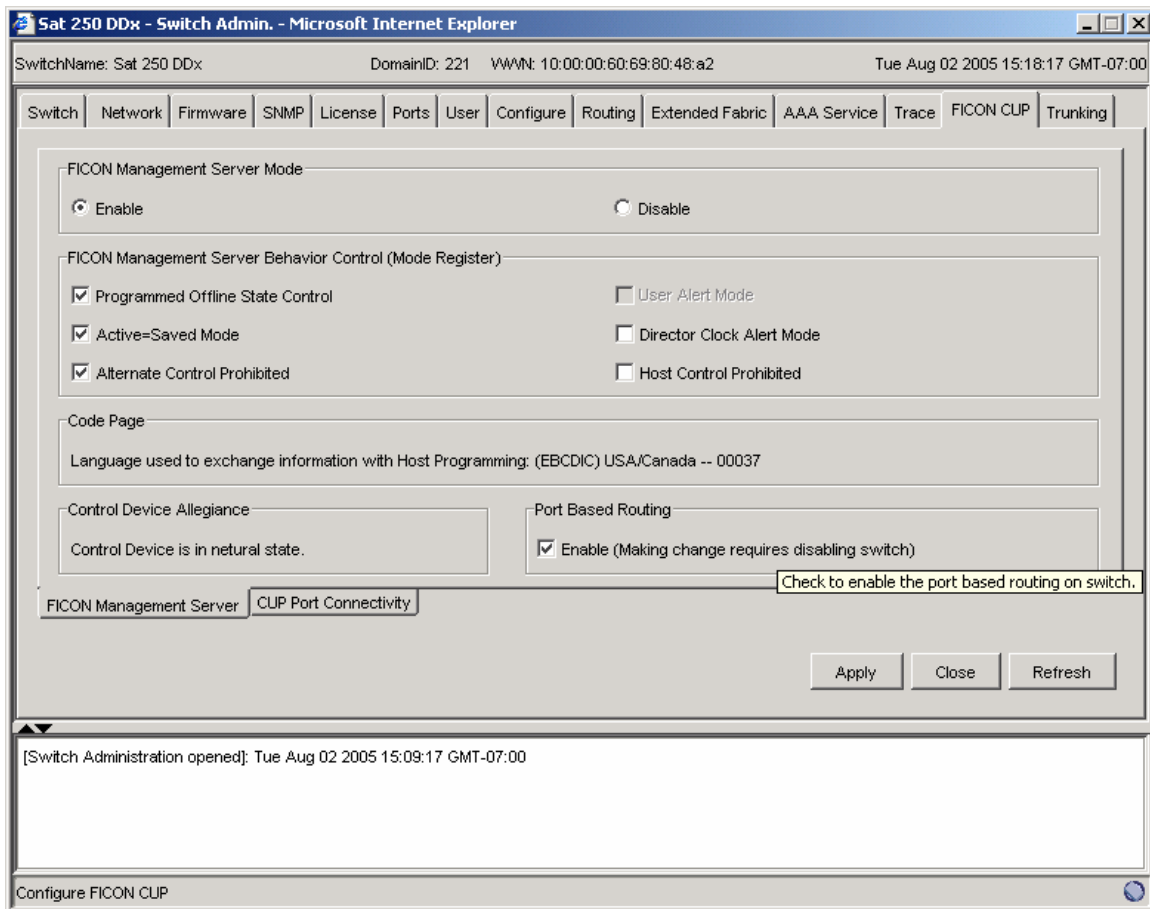
**Figure 12-1** FICON CUP Management, Port Based Routing.

The FICON CUP tab displays, with the FICON Management Server subtab in front, as shown in Figure 12-1.

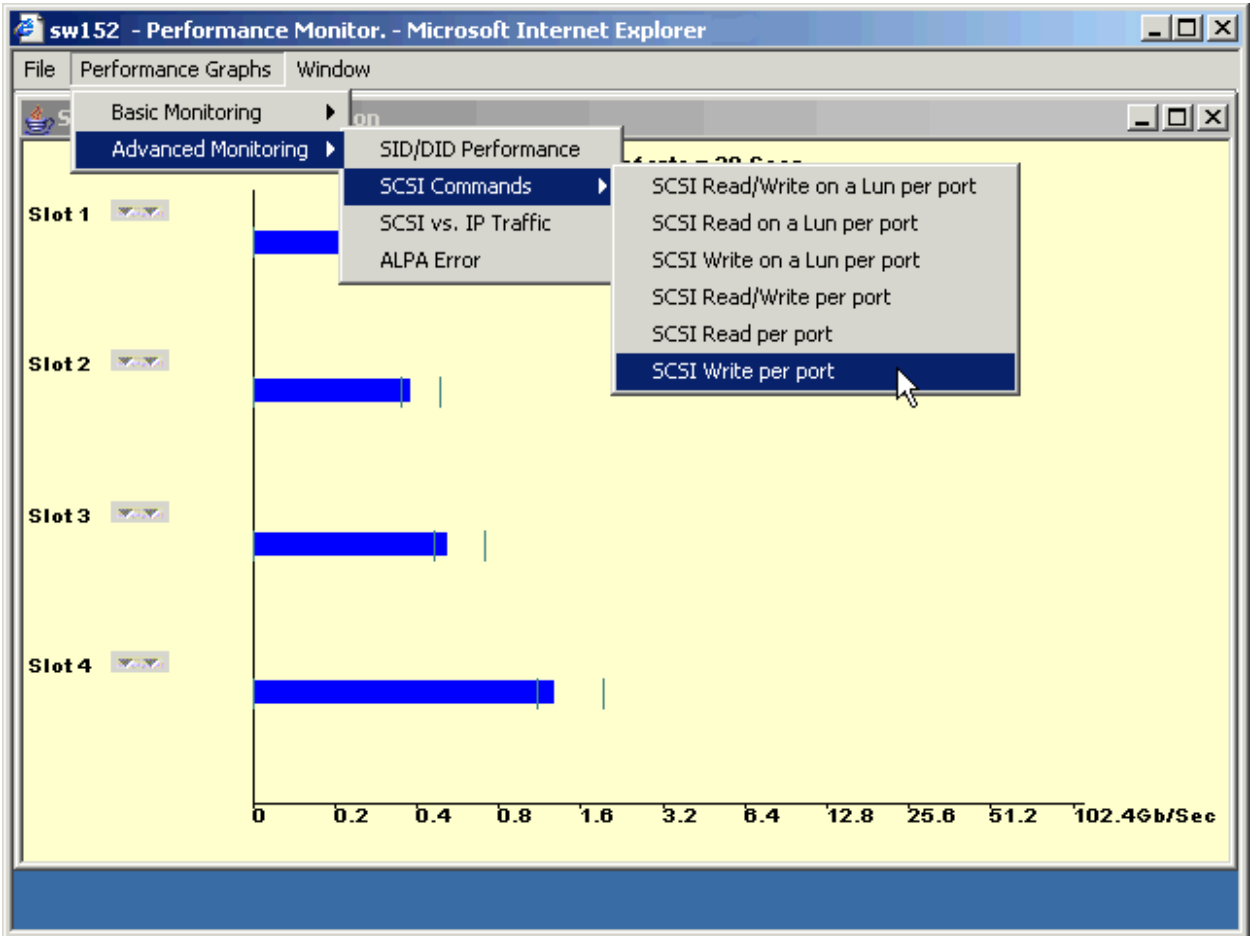
**Figure 14-1** Accessing Performance Graphs

Port throughput utilization is represented by a horizontal bar for each selected port, which gets longer or shorter depending on the percent utilization for that port at the last poll time. Thin short vertical intersecting bars give a historical perspective by representing the highest and lowest values reached for each selected port since the graph was opened. A third bar between them represents the average of all values polled. (See Figure 14-1.)

On page 14-3, replace Figure 14-1 with this one:
